Very high cycle fatigue crack initiation mechanism according to a 3D model of persistent slip bands formation in α -ferrite

Chong Wang, Qingyuan Wang, Danièle Wagner, Zhiyong Huang, Claude Bathias

Chong Wang, Qingyuan Wang, Danièle Wagner, Zhiyong Huang, Claude Bathias. Very high cycle fatigue crack initiation mechanism according to a 3D model of persistent slip bands formation in α -ferrite. *Fatigue and Fracture of Engineering Materials and Structures*, 2015, 38 (11), pp.1324 - 1333. 10.1111/ffe.12348 . hal-01687060

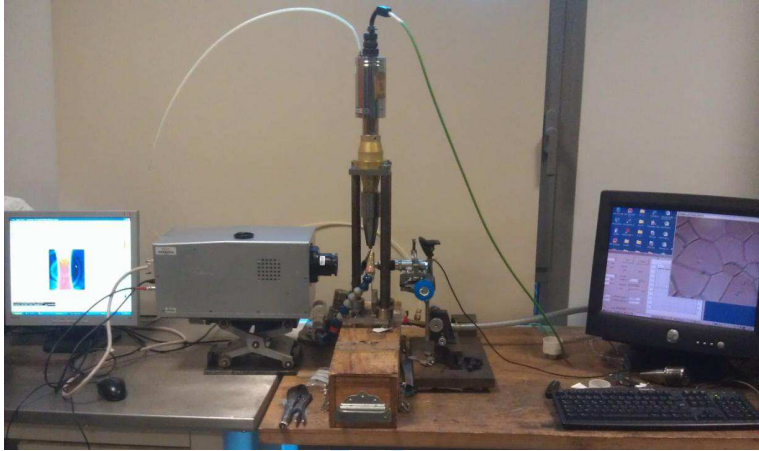
Fig. 2 Experimental system

During ultrasonic fatigue loading, theoretically, the specimen center has zero axial displacement. A small area on the surface which includes specimen center remains visible by microscope because the displacement maintained at very low level. Therefore a mobile optical microscope constructed for taking the online image. It has magnification 320X and recording image at frequency up to 1 Hz. With this mobile optical microscope, it is possible to observe general appearance when character deformation takes place in the specimen surface like enforced slip bands. A CEDIP Orion infrared camera was used to record the temperature evolution during at another side. The frequency of the IR camera was 50Hz and the aperture time was 100 μ s. The typical online observation system is shown at Fig. 2.
